June 16, 2011

RE: Response to the e-mail Forwarded to [REDACTED] Insurance from [REDACTED] on the Dominion Homes Customer Care Response Regarding the Inadequacy of the Stucco Underlayment at the [REDACTED] Residence, [REDACTED].

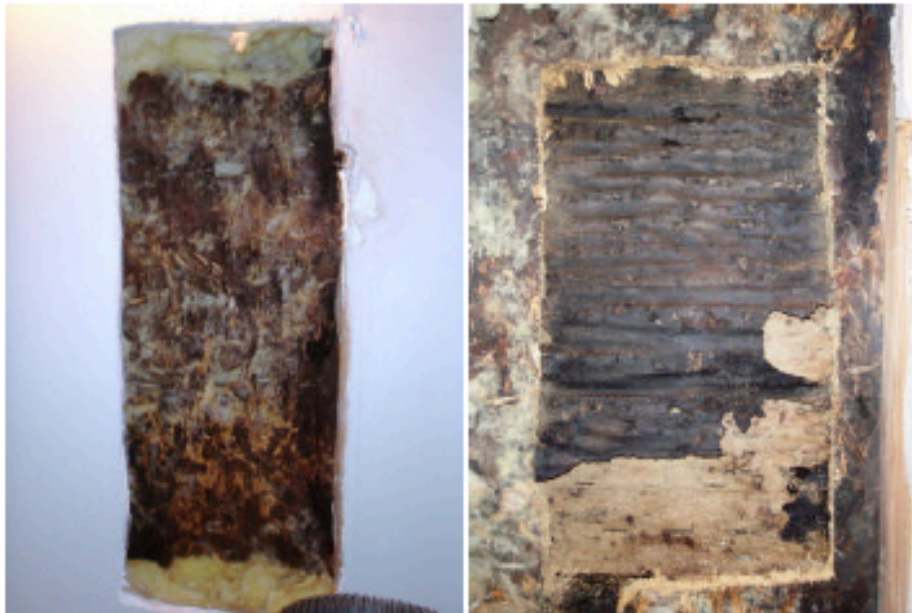
The 2002 Ohio Building Code, along with recommendations from stucco industry best practices, was referenced in regards to the proper integration of a weather-resistant system for an exterior stucco wall system. The references cited appeared to be in agreement that two layers of a weather-resistant barrier (particularly Grade D building paper) were needed as an underlayment between the exterior stucco and wood sheathing in order to adequately protect the sheathing and interior portions of the home from water/moisture intrusion. Further, destructive testing of the south wall of the master bathroom revealed one layer of an apparent building paper between the exterior OSB sheathing (which contained moderate to heavy water-staining and probable visible mold growth) and the stucco wall assembly. This building paper was water stained, heavily rippled in appearance, and was brittle and easily crumbled when manipulated by hand. The appearance and condition of the paper appeared inadequate to provide a proper barrier against water/moisture from coming into contact with the exterior sheathing (see Figures 2 and 3).

Figures 2 and 3: Master Bathroom – South Wall Destructive Testing – Water-Staining and Probable Visible Mold to Exterior OSB Sheathing (left) and Water-Stained and Degraded Building Paper (right)

As outlined in Section 703.1 of the applicable code requirements above regarding exterior coverings, exterior walls are required to be designed and installed in the specified manner given "to provide a barrier against the weather." As mentioned previously and shown in Figures 2 and 3 above, the water-stained and degraded condition of the apparent building paper suggested the building paper was inadequate to properly protect the wall sheathing and interior portions of the home from water/moisture intrusion through the stucco wall assembly.

In Section 703.2 above, although the use of a weather-resistant barrier behind stucco is not specifically mentioned in Table 703.4, it is inferred that it is needed based on exception #4 of the code language which states that it is not required if the lath is already backed with such a weather-resistant material. Further, Section 703.2 requires that the asphalt-saturated felt, or other approved material, be applied horizontally with the upper, overlapping layer lapped over the lower layer "not less than 2 inches". As noted in the original inspection report this is identical to the lap requirement given in stucco industry best practices. As observed during the destructive testing of the exterior OSB sheathing in the south wall of the master bathroom, the horizontal lap in the building paper was measured to be up to 1-1/2". This deviates from the lap requirement in the applicable residential code language above and from stucco industry best practices.

Setting arguments aside and regardless of the code year cited, it is clear that as installed, the waterproofing for the south wall was not functioning properly. This resulted in extensive water damage to these wall cavities.

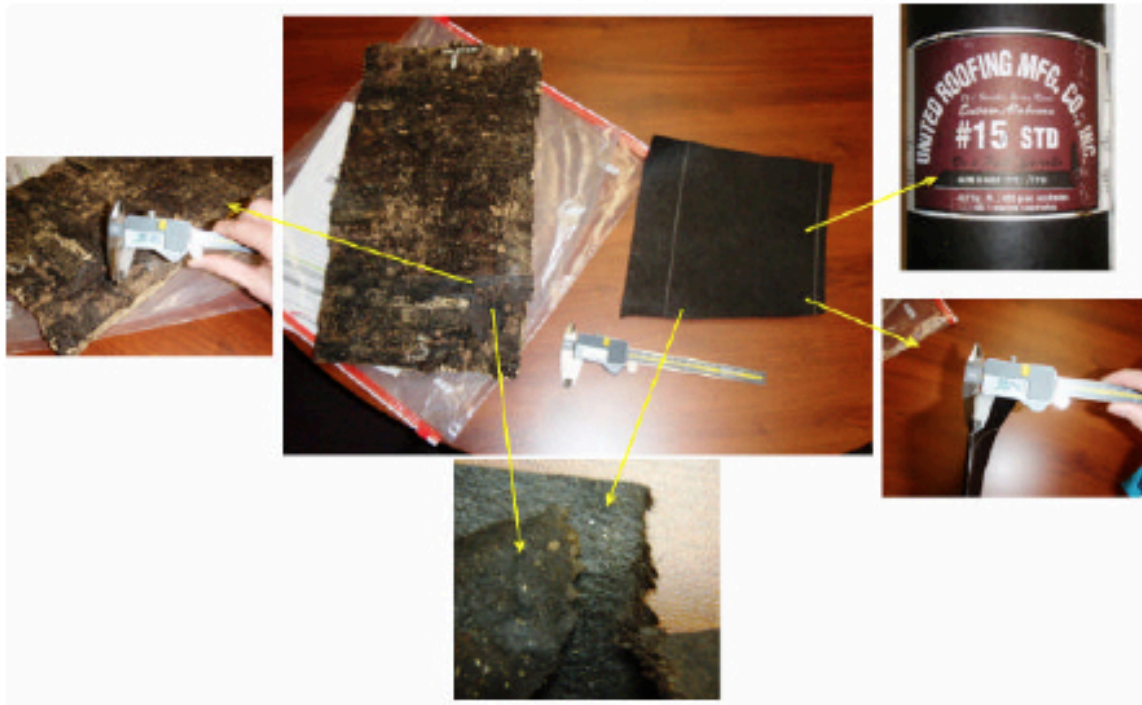
- The #15 felt was much thicker when manually felt by hand.
- The thickness of the #15 felt ranged from 0.0215" to 0.0240" (Figure 4).
- The thickness of the paper on the removed section of OSB ranged from 0.0090" to 0.0110" (Figure 4).
- Both samples were manually torn by hand. The #15 felt appeared to contain numerous large/long fibers, while the paper on the OSB appeared to contain small/short fibers (Figure 4).

Figure 4: Comparison between Stock Type 1 #15 Felt and Apparent Building Paper on Exterior Side of Removed Section of OSB

Based on the comparison performed by [REDACTED] the material on the exterior side of the removed section of OSB was much thinner than the stock #15 ASTM D 4869 Type 1 felt paper. A review of ASTM D 4869, titled "Standard Specification for Asphalt-Saturated Organic Felt Underlayment Used in Steep Slope Roofing", indicated that the net mass of the saturated felt was 8.0 pounds per 100 square feet (0.390 kg/m^2).

In accordance with the applicable code language in the 1999 Ohio Residential Code for One, Two and Three Family Dwellings reproduced above; "asphalt-saturated felt weighing not less than 14 pounds per 100 square feet (0.6683 kg/m^2)" is required as a weather-resistant paper. In order to meet this requirement, at least two layers of #15 ASTM D 4869 Type 1 felt paper would be needed. Based on the physical comparison between the stock #15 felt paper and the apparent building paper removed from the home, the net mass of the building paper would be much less than that of the #15 felt, therefore more than one layer, or even two layers, would be needed to meet the residential code requirement. Therefore, the lack of adequate design/installation of the weather-resistant paper likely allowed any water/moisture penetrating through the stucco wall assembly to pass through the inadequate building paper and damage the OSB sheathing and limited interior spaces.
